RAILROAD ACCIDENT REPORT

HAZARDOUS MATERIALS ACCIDENT
IN THE RAILROAD YARD OF THE
NORFOLK AND WESTERN RAILWAY AT
DECATUR, ILLINOIS
JULY 19, 1974

NATIONAL TRANSPORTATION SAFETY BOARD
Washington, D.C. 20594
REPORT NUMBER: NTSB-RAR-75-4

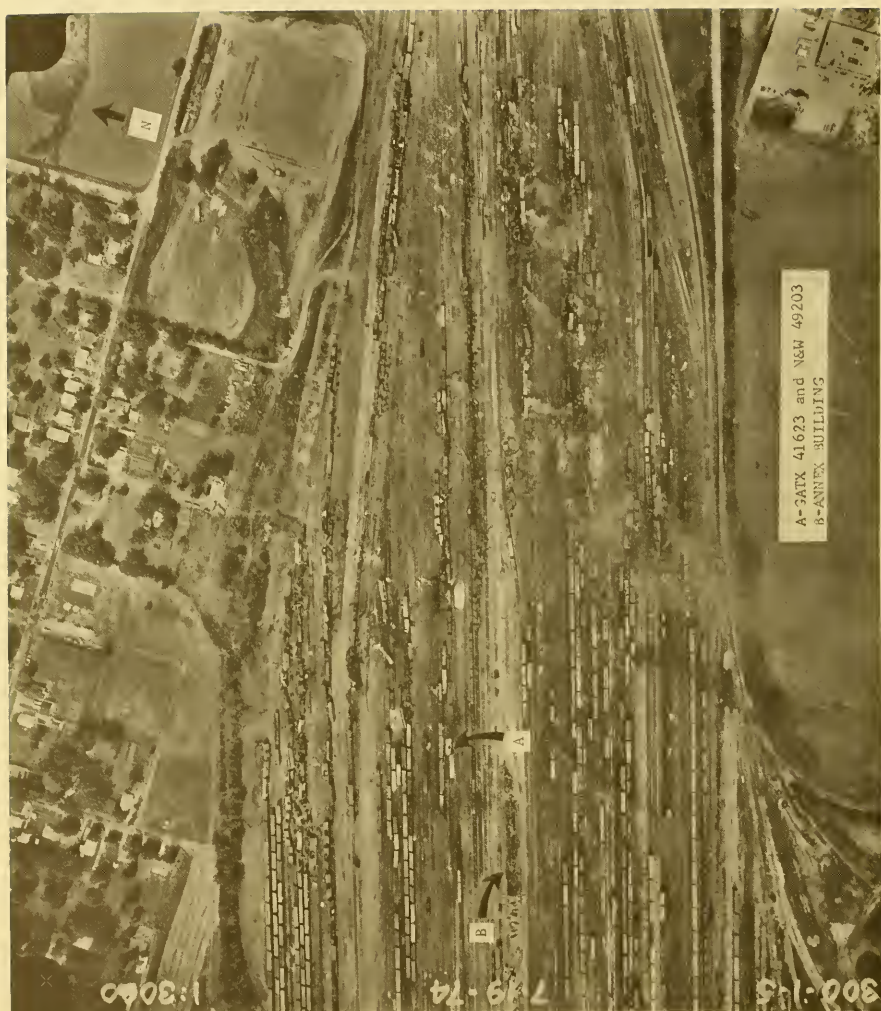
Liquid isobutane spilled from the 22-inch by 26-inch puncture at the rate of about 5,000 gallons per minute. The liquid vaporized, and a northwest wind spread the cloud southeastward for about 8 to 10 minutes. The cloud was then ignited by an unknown source and exploded violently. (See Figure 2.)

Figure 2. The explosion area in Decatur Yard.

At Decatur the open-air explosion of the gas-air mixture is substantiated by two significant facts: (1) All cars containing commodities which could explode were accounted for after the explosion; (2) there were no craters after the explosion. Such an explosion would have required a carload of explosive material and would have caused a large crater.

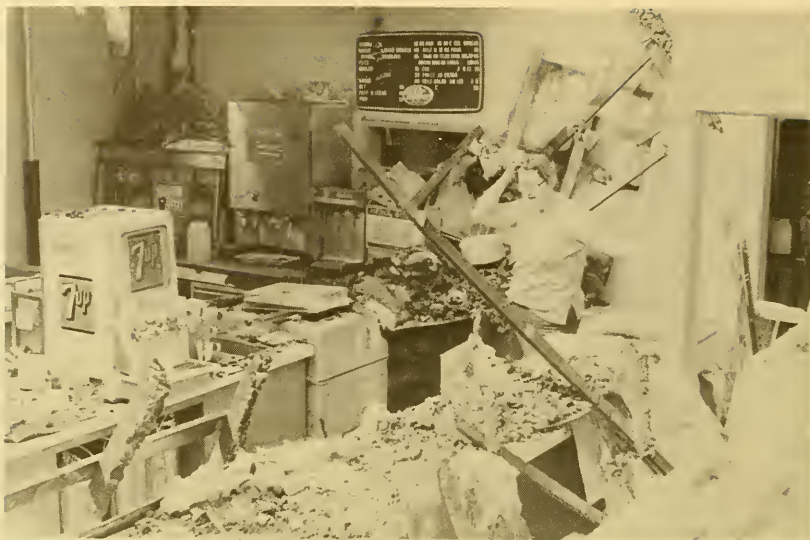
About 700 residences were damaged by concussion, 67 of which authorities declared uninhabitable; damage ranged from broken windows to collapsed roofs and walls. Many furnishings were damaged by flying glass and other debris. Lakeview High School, which was adjacent to the east-bound yard, was one of the most severely damaged buildings. An unfinished addition to the school was demolished. Ten other schools were also damaged. (See Figures 3 and 4.) Thirty-one commercial establishments reported damages to structures and contents.

Figure 3. Typical Damage, Residential Area
Decatur, Illinois

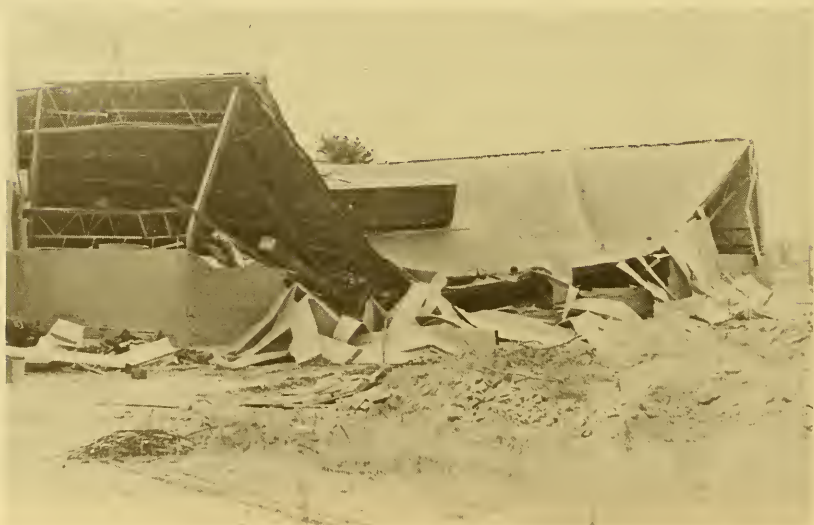
Figure 4. Damage to Lake View School, Decatur, Illinois.

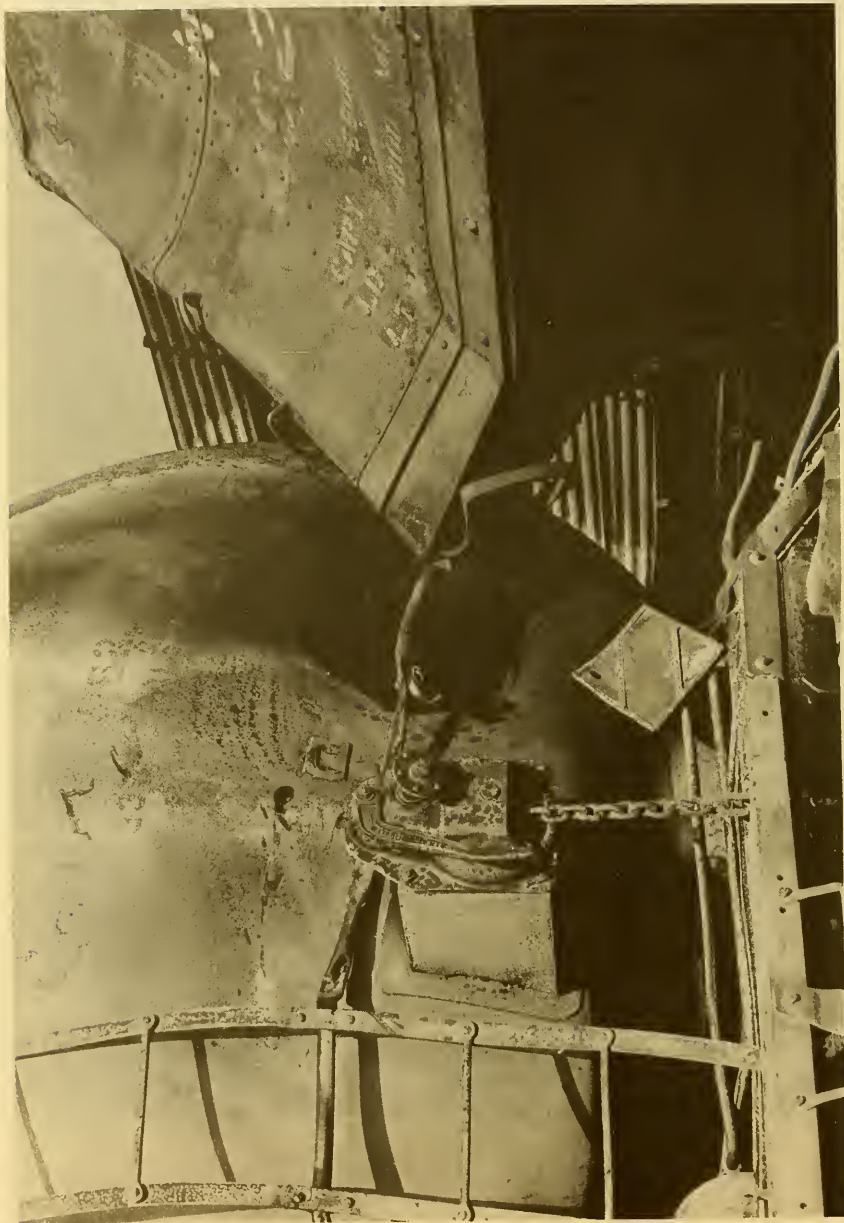
In addition to the 22-inch by 26-inch puncture, the running board, handrail, airbrake equipment, handbrake mechanism, and coupler on the east end of the car were damaged. The east end of the car was also burned. (See Figure 5.)

Figure 5. "B" end of GATX 41623.

The marks on the coupler of the punctured tank car and on the coupler of the empty boxcar clearly indicate that the two couplers engaged at first impact. To puncture the tank, the boxcar coupler had to disengage vertically, override the coupler of the tank car, and strike the head of the tank with sufficient force. The broken carrier iron on the boxcar indicates that an initial downward movement of that coupler, then a rebound upward, caused the vertical separation. That action is consistent with what one would expect when an unusually heavy cut of large tank cars moving at excessive speed attempts to couple to a free-standing light boxcar.
